## Journal of Multidisciplinary Approaches in Science (JMAS)

# Root Cause Failure Analysis (RCA) of Above Ground Vertical Storage Tank Damaged Plate

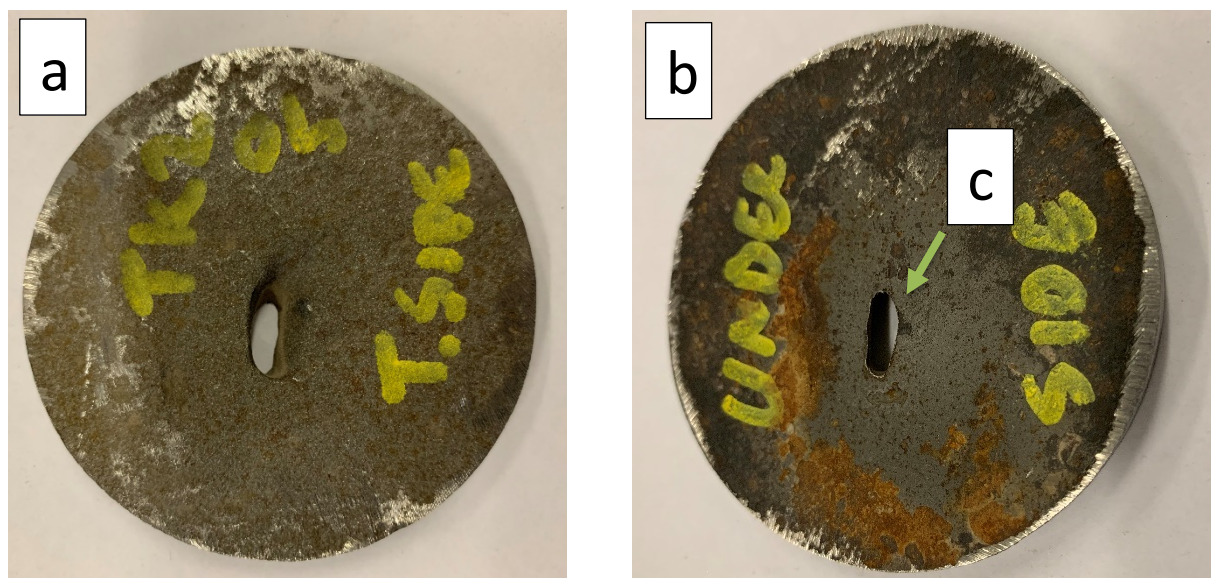
Figure 1. General Views of Portion of damaged tank bottom plate Supplied for Examination (a) Top side surface of tank bottom plate (b) Bottom side surface of tank bottom plate & (c) failed portion

The visual observations of the damaged portion (Figure 1,a) along with the protruded section (metal burr) (Figure 2,b) with magnifying aid indicate partial signs of erosion phenomenon, lack of any corrosion signs. Moreover, it is also observed a characteristic variation of surface roughness between damaged area versus base metal location.

The visual examination of the plate shows one hole with marked cavities besides some pits on the both surfaces (working side) of the plate. A closer view of the plate showing large perforation (hole) in the plate sample. Moreover, there weren't any observation of severe corrosion pitting in a localized band at the surface of plate and the associated damaged region.

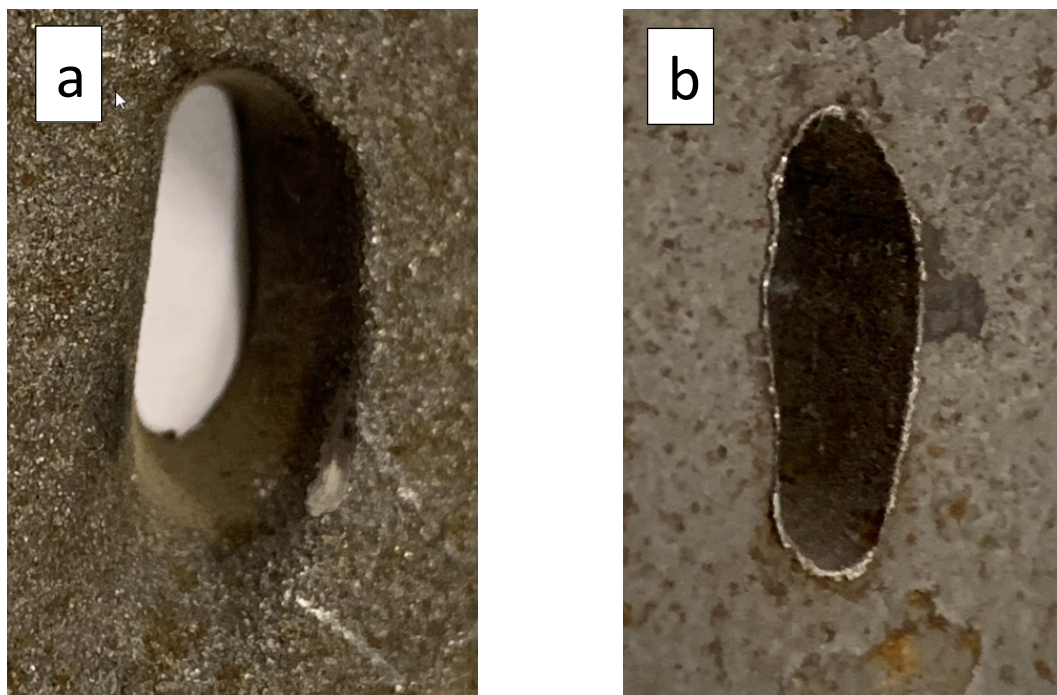
Figure 2. Close-up Views of the failed portion Indicated in Figure 1 (a) Top side plate (b) bottom side of floor plate

1. Visual examination revealed no metal loss near damaged region as we as no visible signs of corrosion scaling. The protruded section (metal burr) from the bottom side clearly shows a forced mechanical entry from the top side, leaving a 12 mm elliptical hole in the damaged vicinity.

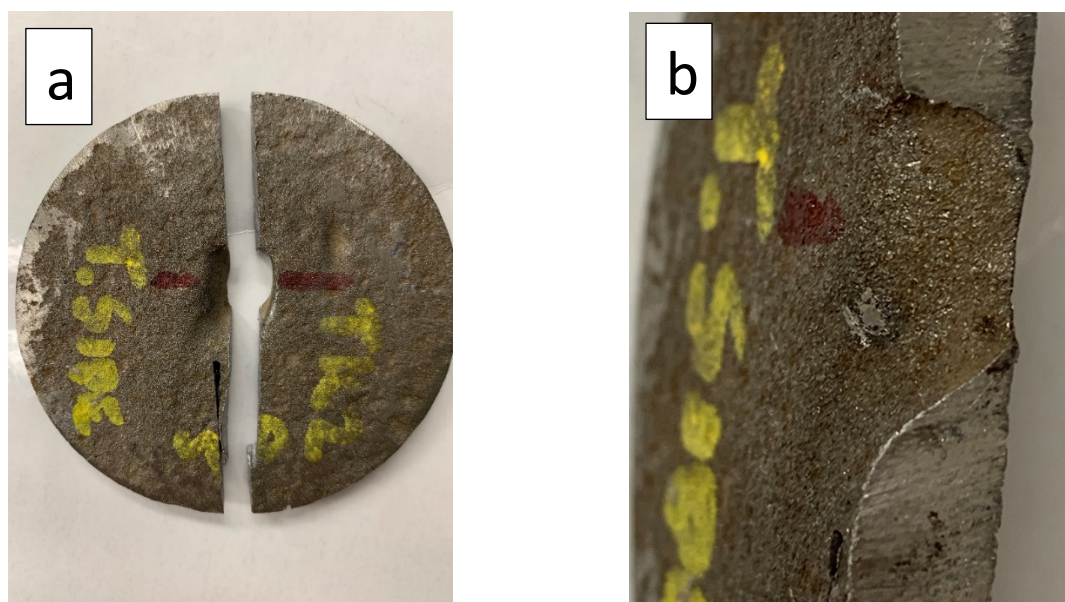
Figure 3. Cut-up Views of the failed portion Indicated in Figure 1 (a) cut view of a plate (b) closed view of failed region

In order to conduct a more detailed examination of the damaged plate, the specimen was cut into two separate pieces, as shown in above Figure 3.

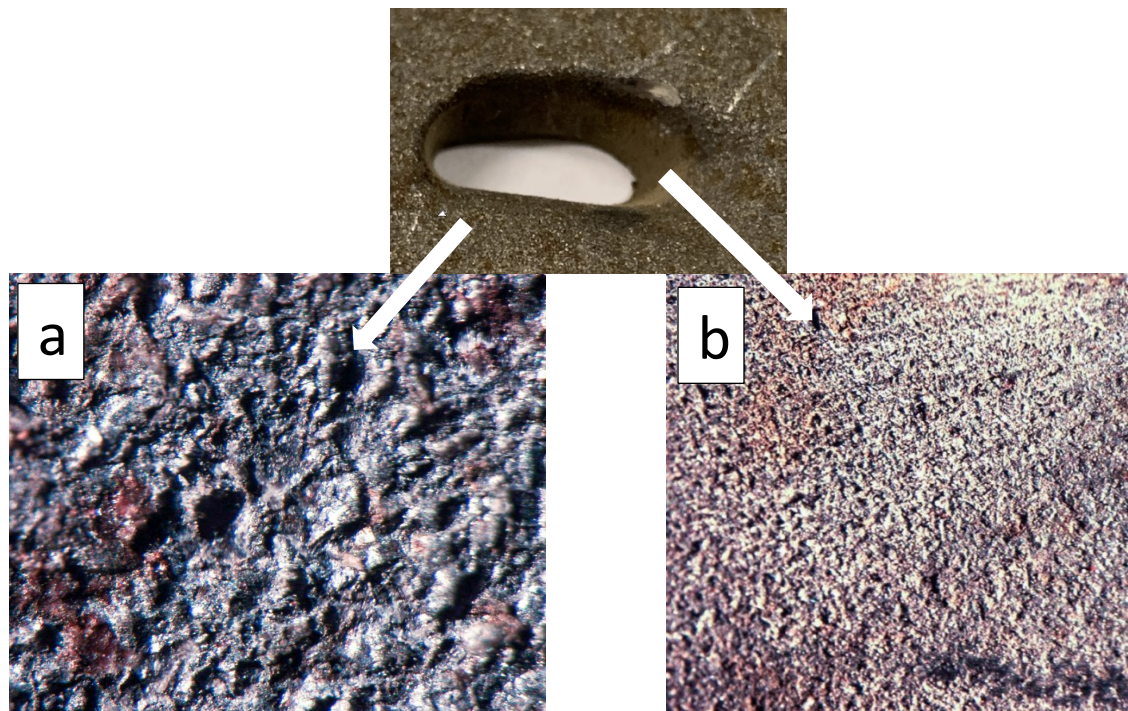
Figure 4. Optical Micrographs of Metallographic Sections at 50x (a) Un-affected Region with minor corrosion (b) Damaged region

As shown in Figure 4a, the un-affected region's surface texture is significantly deviated in the direction of the normal vector of a real surface from its ideal form, resulting the surface in much rough texture as compared to the damaged region (Figure 4b). The same observations were supported by the surface roughness examination analysis.

2. Based on the microscopic surface and Surface roughness examination, both areas have different roughness appearances, showing dissimilar damage mechanisms at respective regions. This may be attributed to the mild corrosion attack at non-affected region as contrary to the damaged portion of the plate. Moreover, the damaged/inside surface exhibit the directional pattern as evident in typical erosion phenomenon.

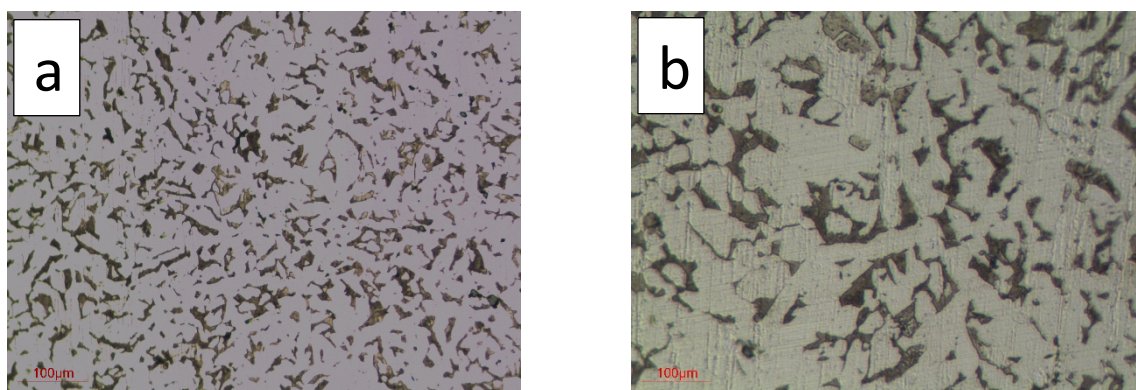
Figure 5. Optical Micrographs of Metallographic Sections at (a) 200x (b) 400x

Figure 5 shows the microstructure of a typical carbon steel[20], which is composed of ferrite and pearlite, consisting of around 60% ferrite and around 40% pearlite. There are no signs of a failure due to the combination of general internal corrosion and more localized corrosion.

3. Microstructural observations illustrate a typical carbon steel microstructure with a pearlite and ferritic bands.
4. There is not a marked deviation observed in hardness values, negating any environmental effects.

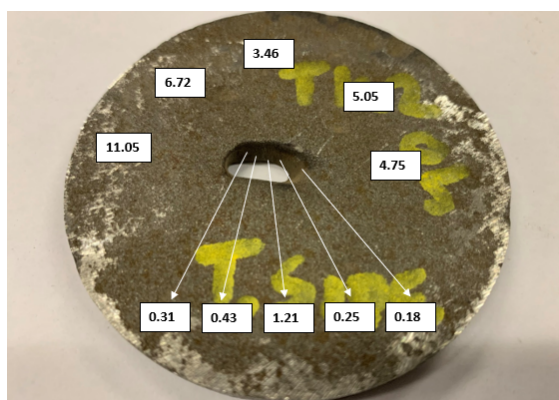
Below figure presented various surface roughness values ( $\mu\text{m}$ ) of un-affected and damaged region locations of the specimen received.

Observed values clearly shows a marked difference in both regions, making the un affected area as rougher than the failed region.
