Failure Analysis of Crashed Helicopter Main Components

M.A.Khattak^{*1}, Miraj Muhammad Jan², S.Kazi³, Abdoulhdi. A. Borhana⁴ & Zarak Khan⁵

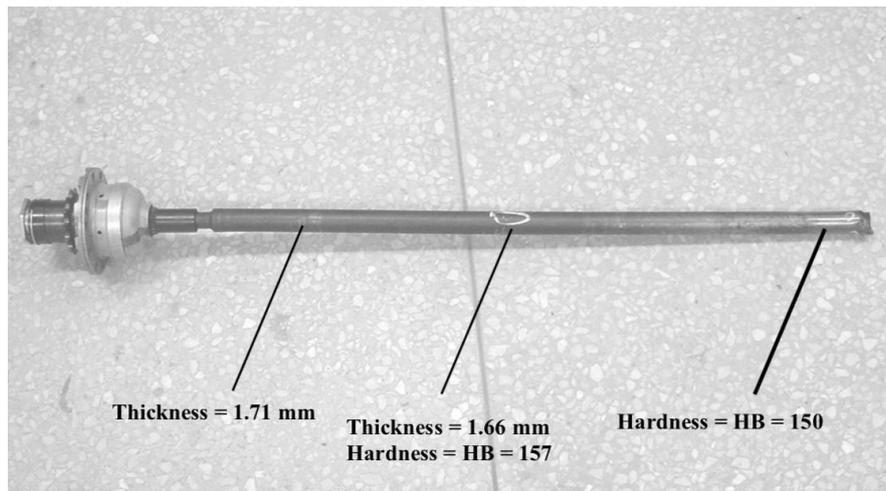
Hardness values of the fractured tail rotor control rod at the locations shown in Figure 4 lie in the range of 150-157 HB. These values are slightly higher than hardnesses of an un-fractured rod of a different helicopter as shown in Figure 5 indicating less resistance to impact failure. The hardness of tail rotor driveshaft is 285 HB.

Fig.4. Hardness & Thickness Measurements of a Fractured Piece

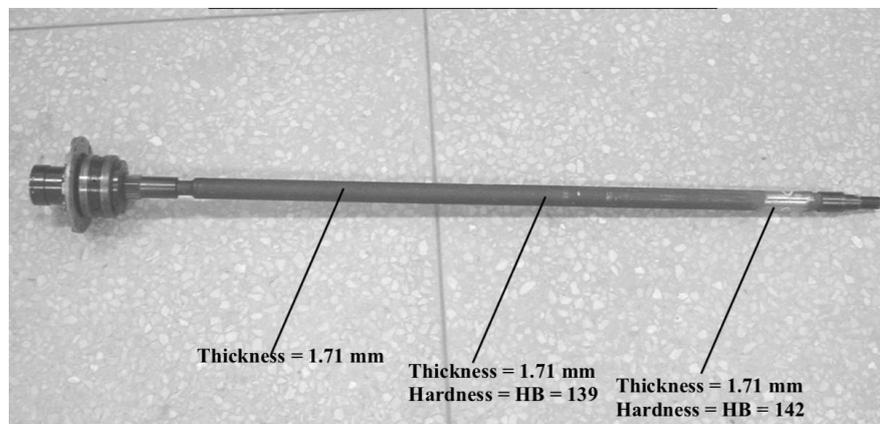
Fig. 5. Hardness & Thickness Measurements of an Un-Fractured Piece

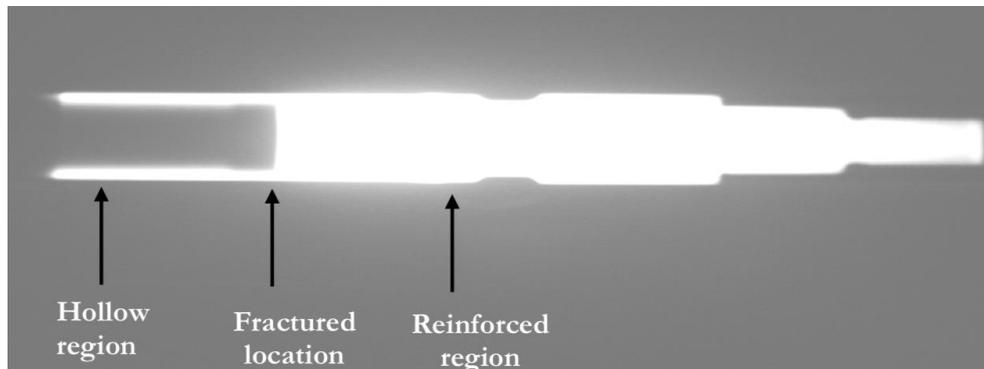
Microscopic examination of the fracture surface of the tail rotor control rod indicated a typical triaxial-stress-state impact loading failure. Triaxiality is induced at the junction of the inside reinforcement and the hollow section of the control rod of 1.71 mm thickness as shown in the X-ray radiographic record of Figure 6, making it the weakest site against any impact or dynamic stress condition.

Radiographic testing of an un-fractured tail rotor control rod of a different helicopter was performed to check the inner geometry of the rod in the fracture region (Figure 6). The radiographic study revealed no gross defects observed in the un-fractured tail rotor control rod.

Fig. 6. Radiographic testing of un-fractured tail rotor control rod

Based on the literature evidence [14-15] of fatigue cracking of helicopter-blade spindle at the fillet between shank and fork, along with the presence of a triaxial-stress-state in the tail rotor control rod, it was recommended that both these components of operating helicopters be subjected to periodical non-destructive evaluation.
