# Evaluation of Vege-Grout Treated Slope by Electrical Resistivity

Soil stabilization using bio-grouting method based on microbial induced calcium carbonate precipitation (MICP) technology has been developed recently to improve the engineering properties of the soil. This new technology could provide an alternative to traditional methods of soil stabilization using soil-cement and chemical grouting. Vegetable waste is a good source for the growth of various kinds of microorganisms which is suitable to be applied as bio-grouting material. The bio-grout extract known as vege-grout was able to induce bio-cementation and bio-clogging process. In this study, vege-grout from vegetable waste was injected into the soil to strengthen the slope and improve the mechanical properties of the affected area. The changes in the subsurface soil after treatment with vege-grout were evaluated by electrical resistivity measurement. Resistivity test showed the resistance in the soil has increased after the grouting using vege-grout. Results indicated that the underneath soils have transformed from medium dense sand to dense sand. The water containment in the subsurface appeared to shift deeper into th

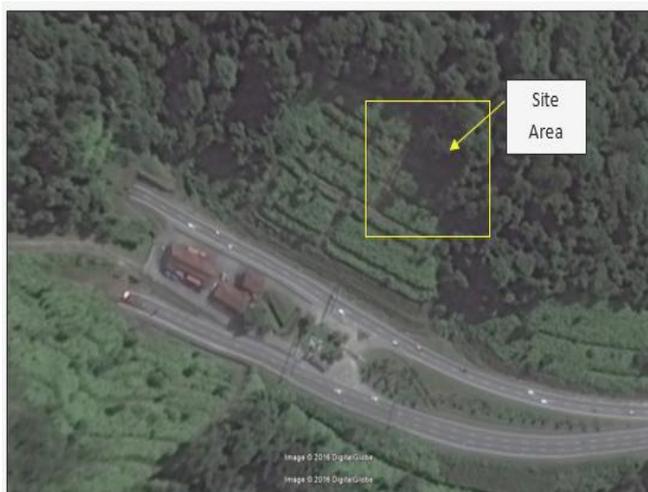
Fig. 1: Study area for field experiment

The study area was a cut slope located along a North South Expressway as shown in Figure 1. The geological description of the area composed mainly of granitic rock from igneous activity. Granite is one type of igneous rock composed of a variety of minerals such as quartz, feldspar and mica. Granite is hard, tough and resistant to fracture because of the interlocking structure of the minerals within it but due to weathering and set of discontinuity occur at the particular area, the strength of granite is reduced. This site is underlain by intrusive rocks, mainly Biotite Granite which consists of fine, medium and coarse-grained granites. Most of the granite that was exposed here has undergone weathering process. Due to this weathering process, the exposed rock is made up of Weathered Granite Grade IV to VI. This granite intrusion was then covered by the quaternary sediment that can be seen around the hill. Geophysics survey of the site area indicated that the soil was made up of Clayey SAND and weathered granite. Sandy soil was the main type of soil in this area

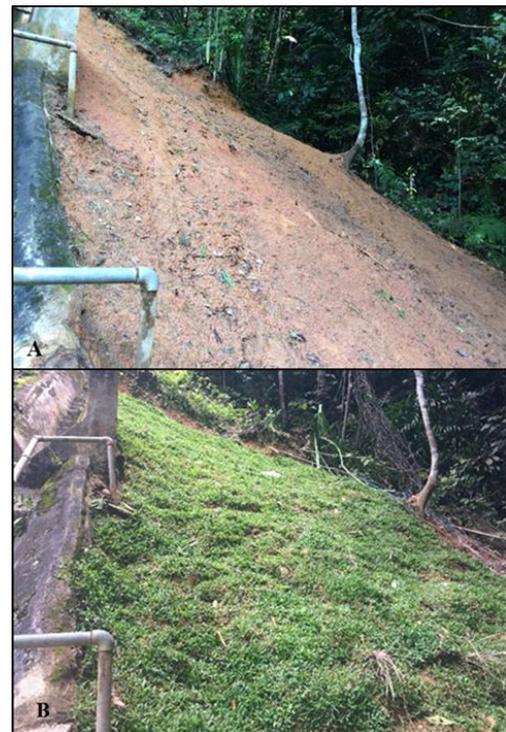
Fig. 7: A) Study area showed eroded surface B) After vege-grout treatment, study area showed growth of grass covering the top-soil

The observation and resistivity results of the study area treated with vege-grout are shown in Figure 6. The saturated layer showed zones of low resistivity with groundwater in the subsurface. After the vege-grout treatment, the resistivity values were higher due to the hardened composition of the soil. Hard layer was detected with range of resistivity value more than 250 ohm-metre. The hard layer consists of weathered granite grade V to II. From the results of the resistivity value, the value showed an increase from 300 ohm.m to 5000 ohm.m indicating that the soil has been transformed into medium dense to dense sand. After approximately two months, the surface area has been covered with new vegetation such as grass and small plants that helped to reduce erosion (See Figure 7). Studies have shown that grass and shrubs are very effective in reducing run-off and erosion effects [19]. Scanning electron microscope (SEM) observation of the treated soil showed evidence of bio-clogging between the soil particles due to the microbial activities in the soil and vege-grout (Figure 8).
