**EVALUATION OF MOTOR BEARING CONDITION IN
COMBINED CYCLE POWER PLANT USING VIBRATION
ANALYSIS**

**A Thesis Submitted to the College of Graduate Studies, University
Tenaga Nasional in Fulfilment of the Requirements for the Degree of**

Master of Electrical Engineering

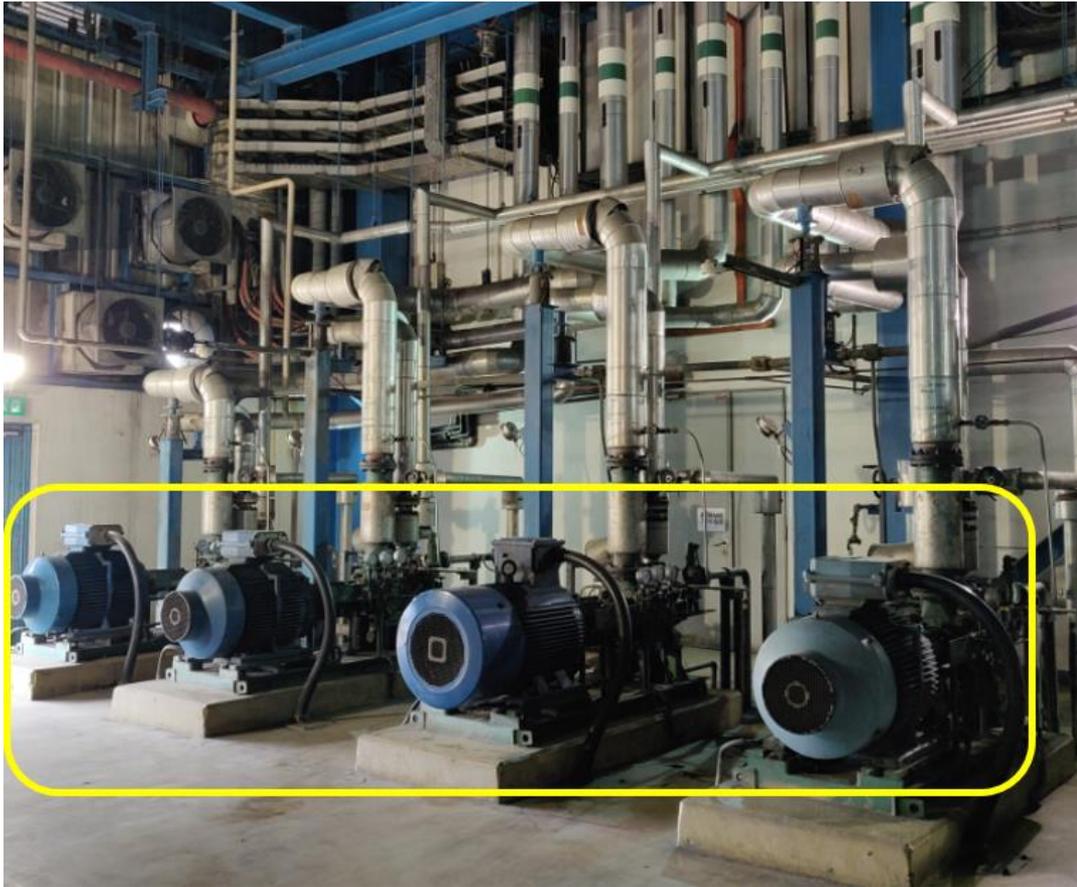
Figure 3.2 The actual LPFW motor on site at the CCPP

As shown in Figure 3.1 and Figure 3.2 (yellow circle), KLPP has four units of the LPFW motor. Three units of the motor will be operating, and one unit will be on standby. The red indication in Figure 3.1 shows motor is running while the green indication shows the motor is off and standby. The pipeline pressure after the LPFW motor must be around 15-20bar, so that all three units of HRSG can be fully operating while the plant on base load (around 660MW). Sudden catastrophic trip of any one or two of the LPFW motor shall affect the overall MW output of the plant.

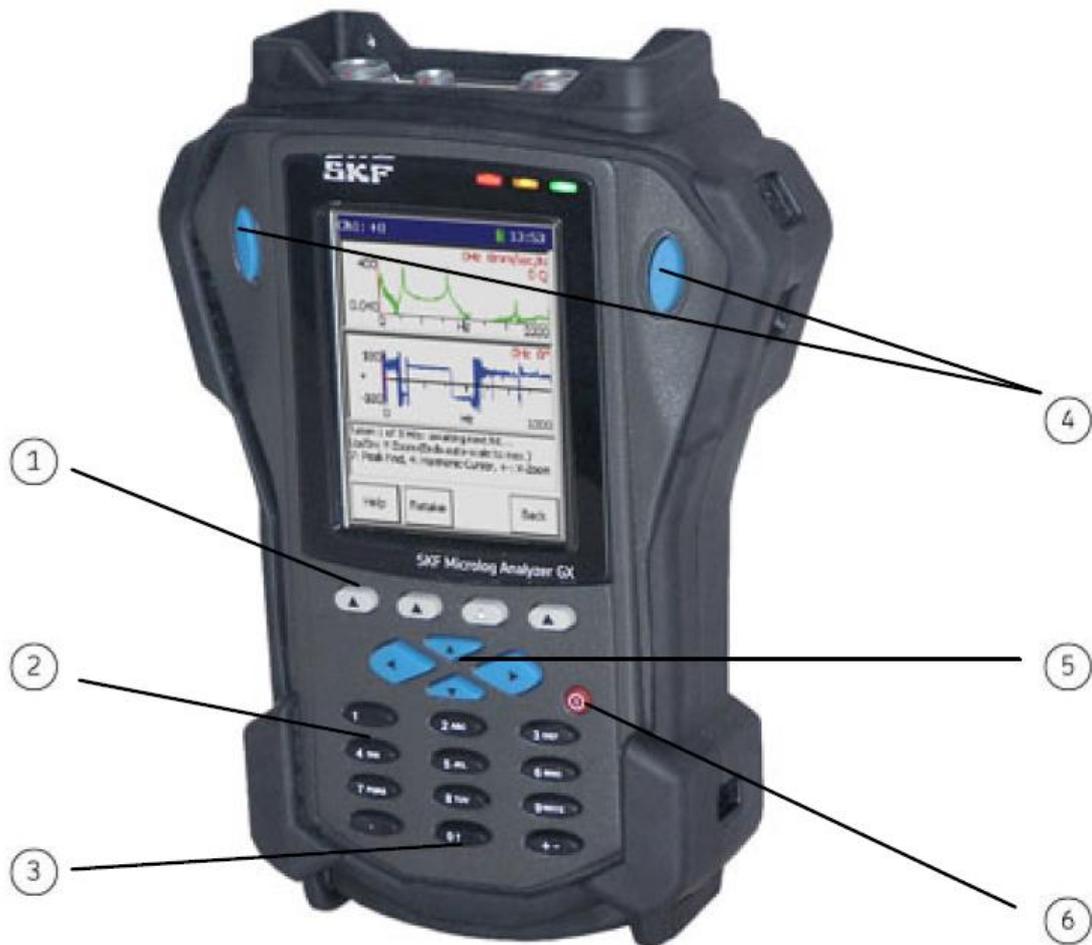
Figure 3.5 The SKF CMXA75 GX Series Device

This project will mainly collect and analyse electrical motor vibration data and relate it to maintenance. For this vibration data, the main equipment to be used is the SKF Microlog GX series data collector/analyser (firmware version 4.x) [48]. The part number of this equipment is 32298500-EN with revision C manual. This GX Series Microlog device as shown in Figure 3.5 is used to collect and analyse vibration data. This device is used to collect all rotating machinery vibration, temperature and other condition monitoring measurements.

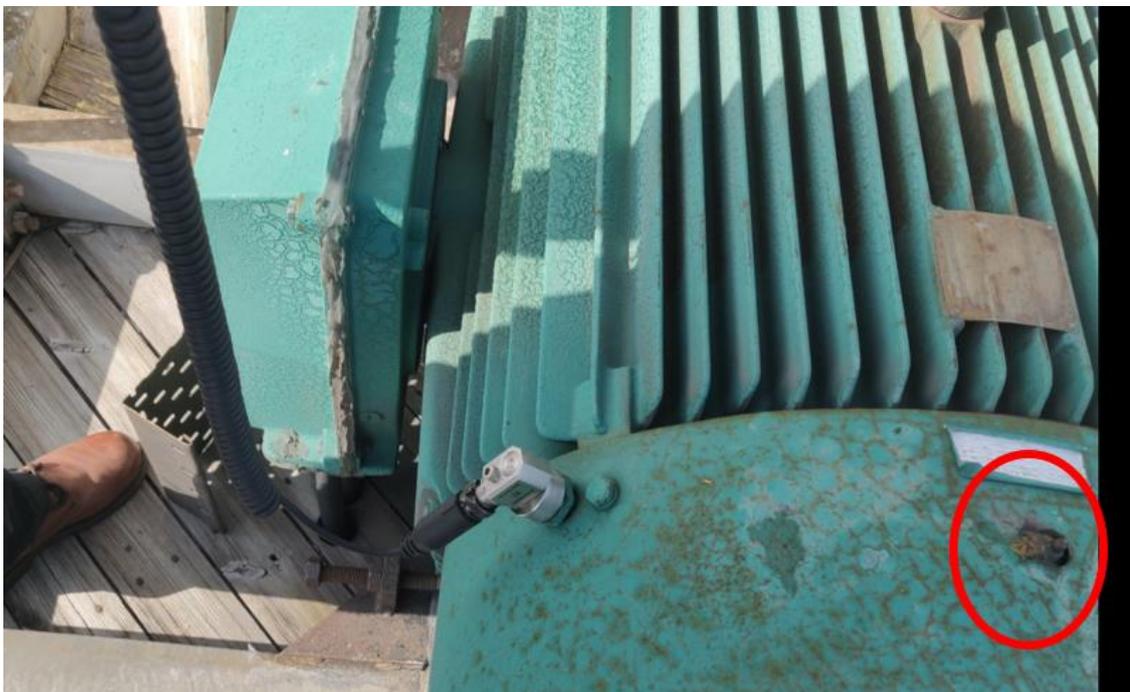
Figure 4.7 Shows sample electrical motor greasing point

Therefore, online greasing was performed by KLPP Electrical Technician recommended by KLPP Condition Monitoring Engineer. Shell high temperature electrical motor grease was applied. Online greasing means, grease is applied without motor shutdown. There will be a greasing pinpoint in the motor (Figure 4.7) for both DE and NDE bearing side. Thus, grease was pumped using the greasing pump with a certain quantity. After 1 hour of motor running at full speed and load, the vibration data were collected to counter check whether the problem was solved. The vibration data collected are as shown below in Figure 4.8 to Figure 4.13.

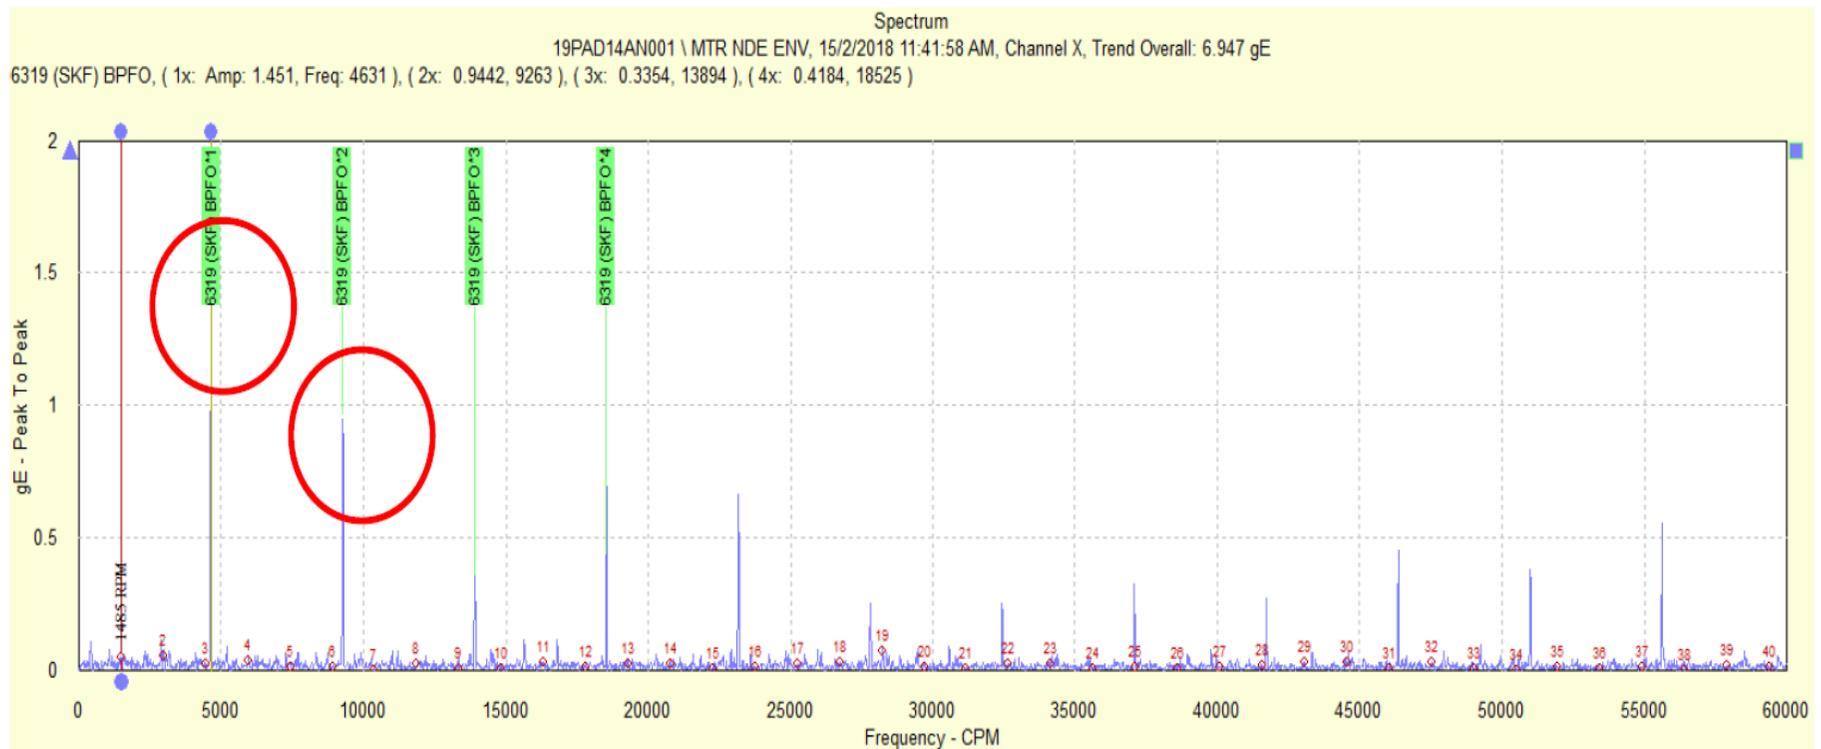
Figure 4.15 CT no.4 Motor NDE Enveloping Spectrum

II. CT Fan Motor no.4 NDE Enveloping Spectrum Amplitude is shown in Figure 4.15, which shows that the motor NDE enveloping spectrum readings were not satisfactory. The spectrum analysis shows that ball pass frequency outer (BPFO) start to fail where the highest amplitude at 1*BPFO is 1.4gE, 2*BPFO is 0.9gE and 3* BPFO is 0.8gE as shown in Figure 4.15 red marked. Based on the vibration diagnostics chart [48], this clearly indicates that the bearing is defected. Hence it is recommended to replace the NDE bearing.

After taking the vibration reading and analysing by referring to [48], it was found that the main root cause of the abnormal sound and vibration was due to two reasons. First, the bearing was defective on the NDE side only. Second, the motor base frame was damaged. Therefore, the proper timing was selected to shut down the machine. For this CT fan motor, usually 1 out of 10 fans will be shut down during power plant low load profile (where plant generating only 40-60% plant capacity). This opportunity will be utilized by the maintenance team to perform their maintenance job. This time is the best to optimize the plant maintenance time and cost. During this time the motor no.4 was shut down and isolated. KLPP Mechanical and Electrical Team Members performed the preventive maintenance. First the motor bearings were changed on both the NDE, the DE side and lubricated sufficiently. Secondly, the motor base frame shim was found to be broken, was also replaced with a new shim and motor alignment was performed. After 1 hour of motor running, the vibration data was collected to verify whether the problem has been solved. The vibration data collected were shown in Figure 4.20 to Figure 4.23 (page 71 – page 74).

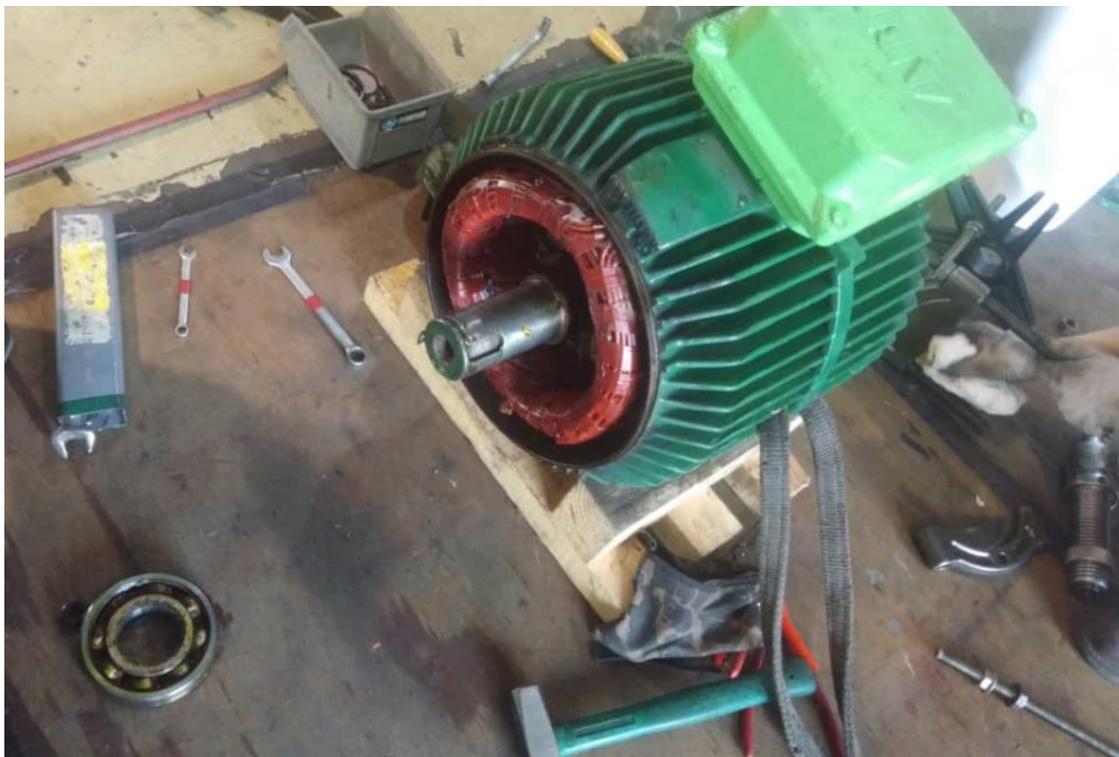
Figure 4.18 CT Fan Motor Bearing Replacement at KLPP Workshop

Figure 4.18 and 4.19 show that the bearing and shield problem has been resolved as recommended. Thus, the new vibration data should be normal.

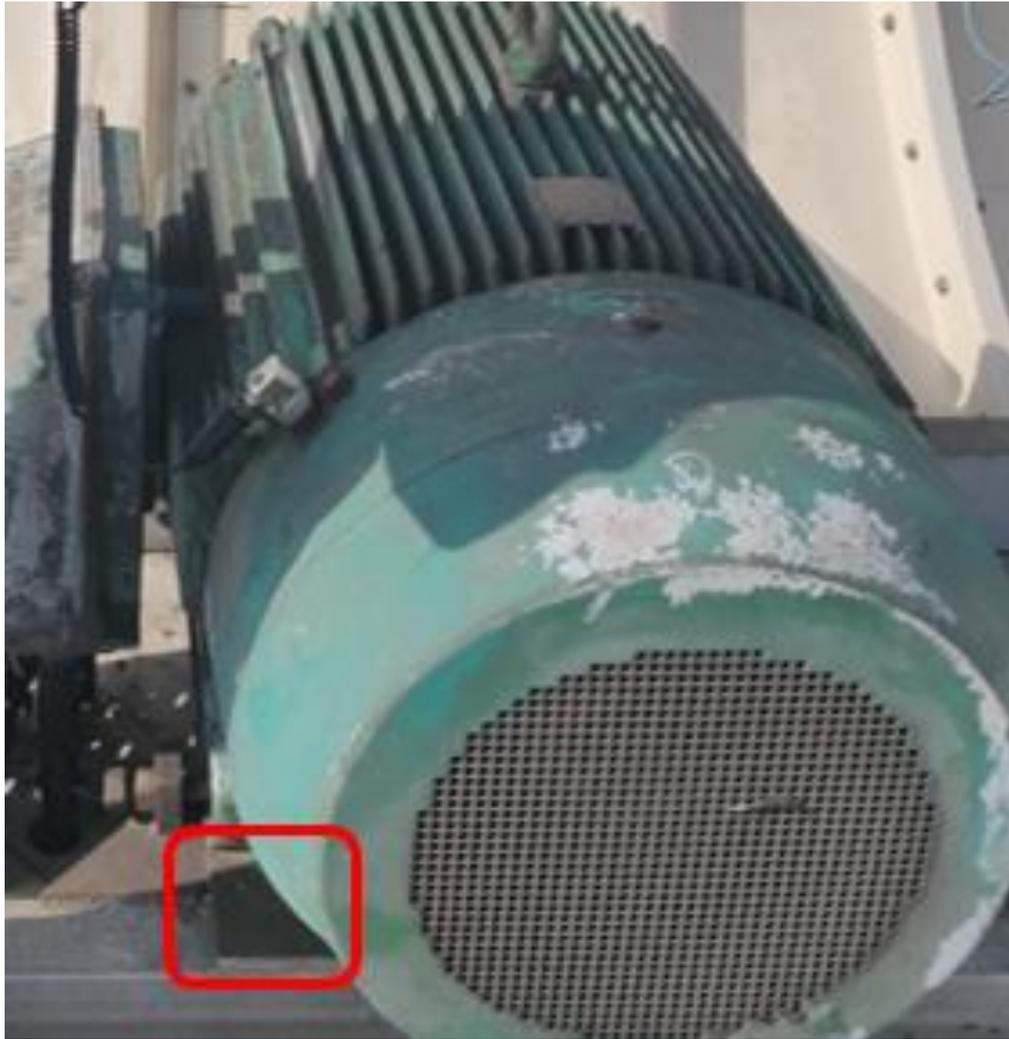
Figure 4.19 CT Fan Motor Base Frame Shim Replaced
