Failure Analysis of Crashed Helicopter Main Components

M.A.Khattak^{*1}, Miraj Muhammad Jan², S.Kazi³, Abdoulhdi. A. Borhana⁴ & Zarak Khan⁵

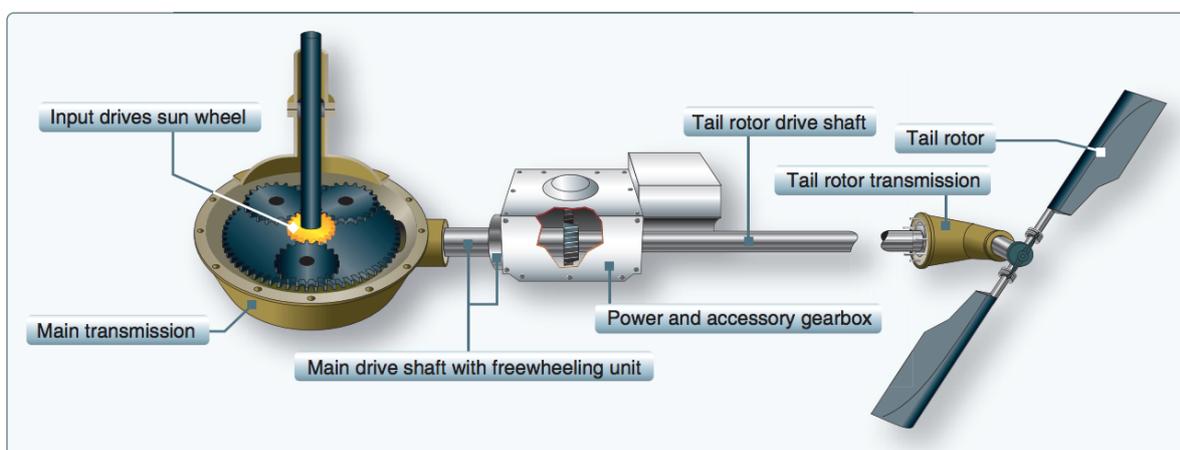
One of the helicopters came down and major components/assemblies were recovered from the crash site. It was desired to isolate the cause of failure of the crashed helicopter by characterizing fracture mechanisms of the main rotor blades, tail boom sections, tail rotor control rod, tail rotor driveshaft and tail pylon (Figure 2).

Fig. 2. The tail rotor driveshaft is connected to both the main transmission and the tail rotor transmission.
